**Lawrence Berkeley National Laboratory
Building 58 Electrical Safety Event
Of June 2, 2005**

Report Date: June 23, 2005

Incident Date: June 2, 2005

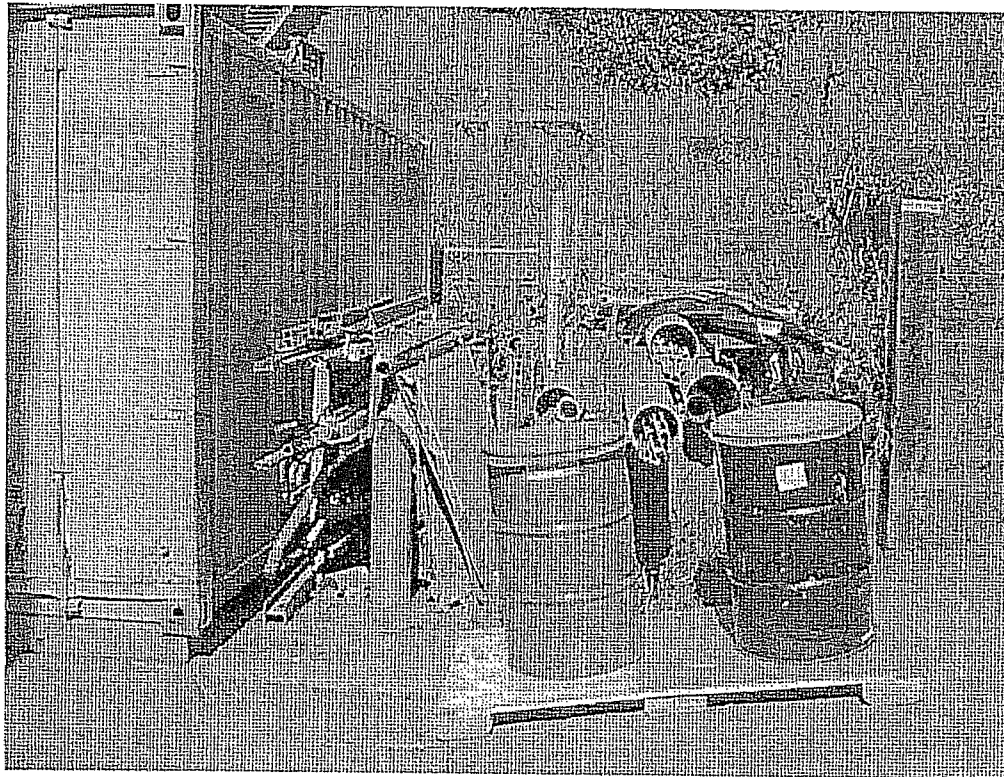
04/25/05

Building 58 Pad Area Before Cleanup Began

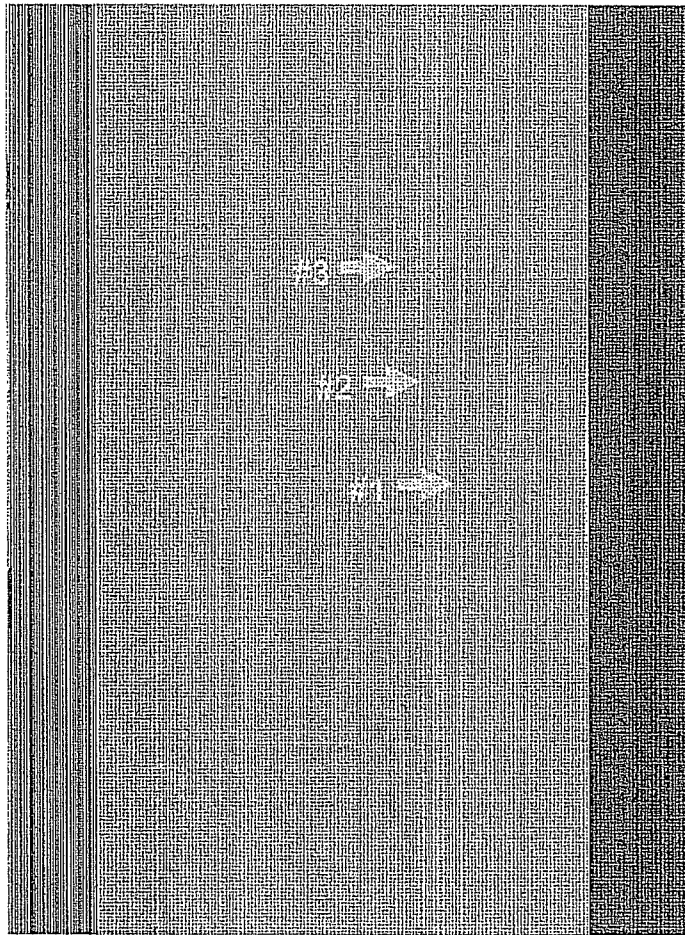
**Building 58 Pad
Area After
Cleanup showing
location of metal
pipes**

(Arrow 1 points to
location of electrical
conduit)

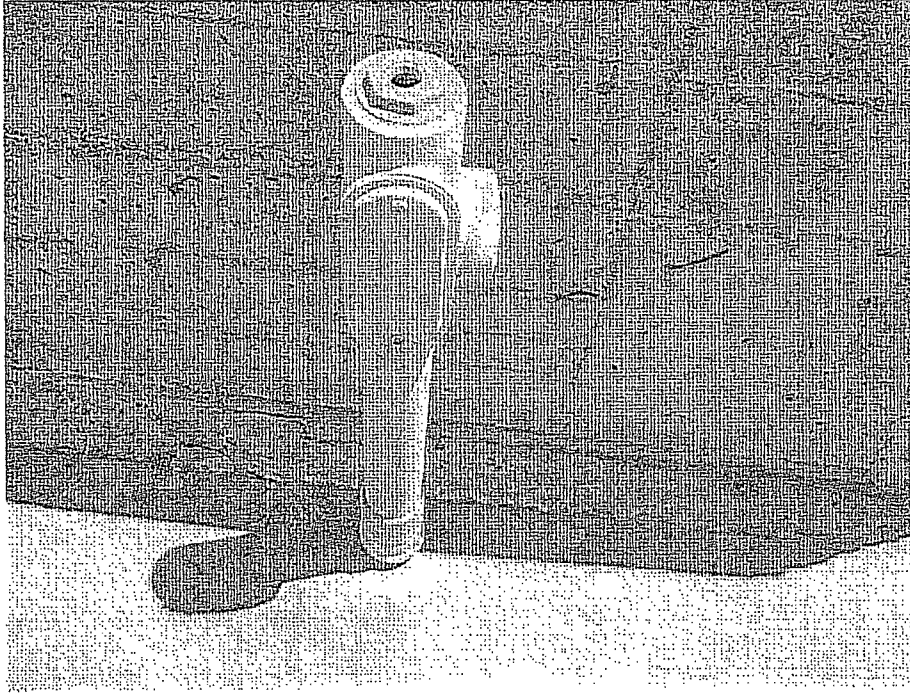
- ~1030 The Mechanical Technician stated he attempted to unscrew the conduit coupling; however, corrosion prevented him from disassembling the conduit arrangement. The Mechanical Technician stated that he began cutting the conduit coupling at an angle to weaken the corrosion and allow the conduit coupling to be removed by manually turning. The cutting was also performed with a PortaBand Saw with plastic handles that provided some electrical insulation. The employee was wearing safety glasses and leather gloves. No one else was in this immediate work area while the work was being performed. After cutting through the coupling threads, spraying lubricant and tapping the coupling, another unsuccessful attempt was made to remove the coupling. The Mechanical Technician cut further. Approximately half way through the electrical conduit coupling, the Mechanical Technician heard a loud popping sound and yanked the PortaBand Saw out of the cut to see a quarter-size section of the blade missing where 1/8" to 3/16" of the back edge of the blade remained intact to retain the full circumference of the blade. The Mechanical Technician understood that the saw blade had contacted live electrical wires. No electric shock occurred.

Building 58 Pad, Electrical Conduit (Coupling, pipe and T-condulet stack reconstructed atop pipe cap)
